Navajo Abandoned Uranium Mine

Site Screen Report

Mine Name: Black Rock Trench
Mine ID: 250

April 2012

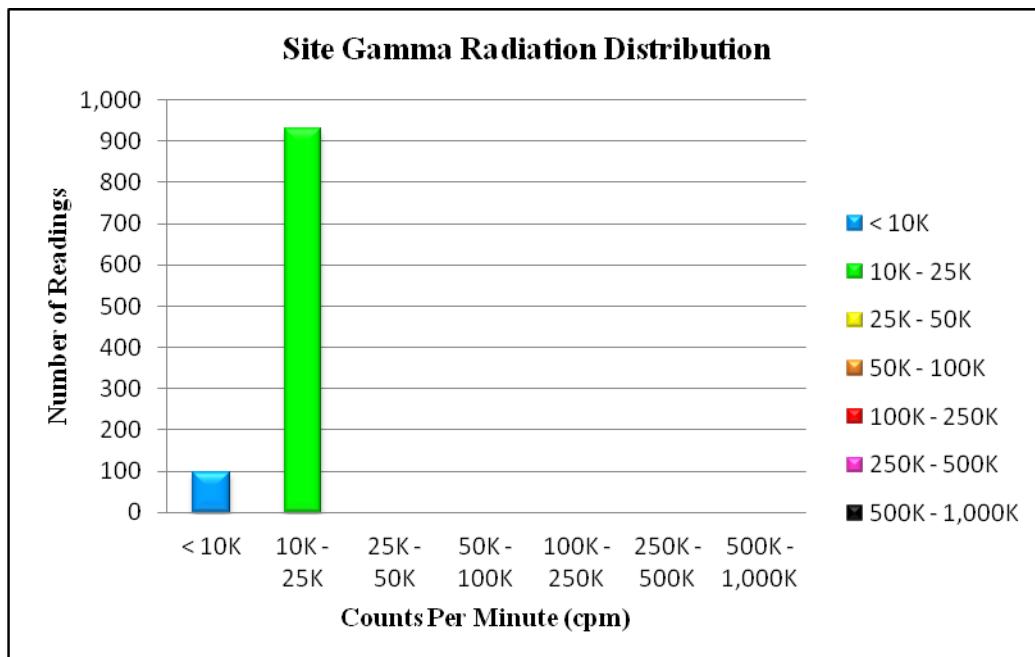
Highest gamma radiation measurement: 23,194 counts per minute (cpm)

Background Average: 7,697 cpm **Two Times Background:** 15,394 cpm

A total of 1,026 gamma radiation measurements were collected from the mine site, ranging from 6,422 cpm to 23,194 cpm. Maximum levels of approximately 20,000 cpm were found near the reclamation cap. The measurements are represented in Figures 1 and 2.

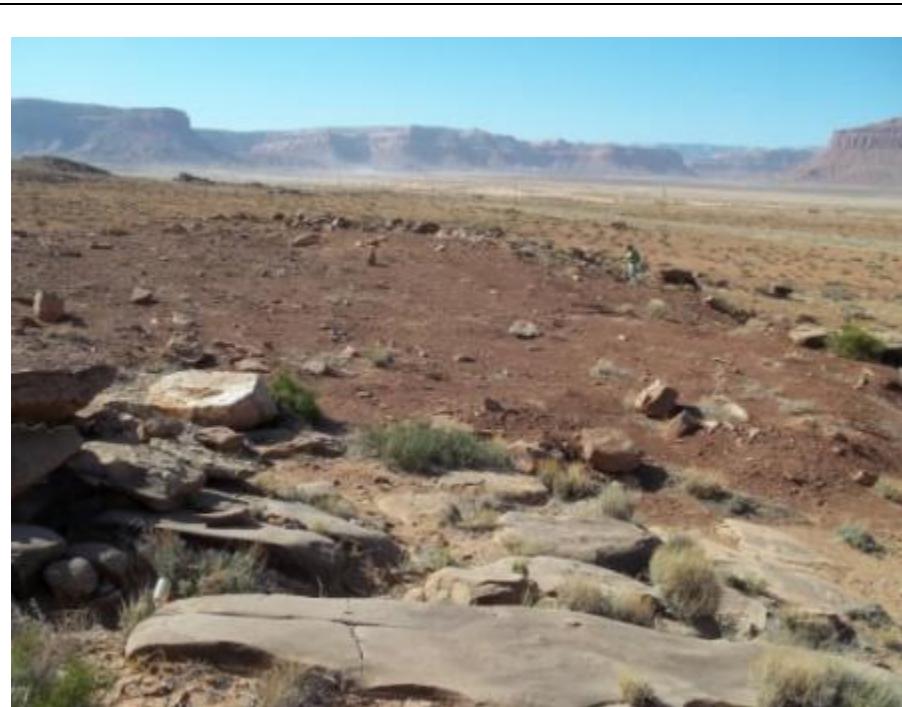
Photo 1

Reclamation cap, red clay, 150' diameter

Mine Site #250
